## TRC Worldwide Engineering

**RE: Report of Structural Condition Survey and Analysis  
Lighthouse Pointe Condominiums**

### **EXECUTIVE SUMMARY**

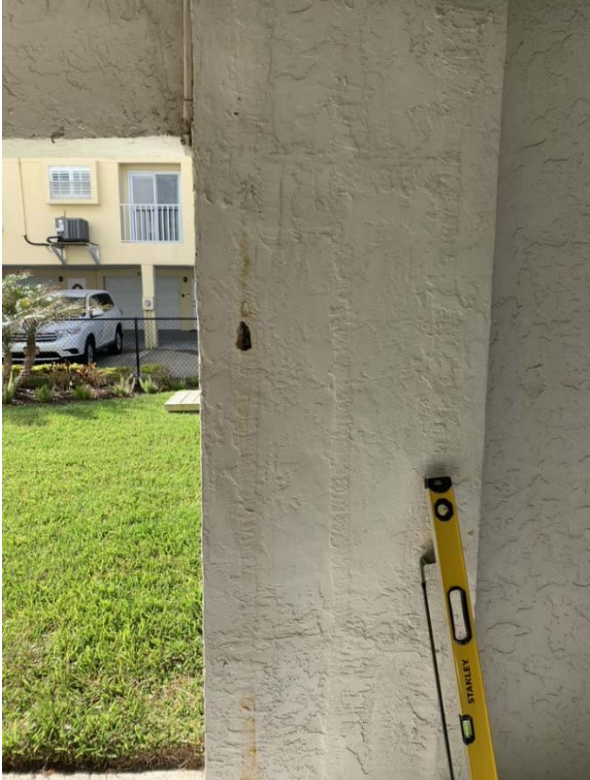
**Photo 1**

- 1) Throughout the property, TRC observed many columns with vertical surface corrosion that appeared to align with the active cathode protection wire/line system. (See Photo 1,4,10).
- 2) The roof was not overloaded and was generally in good condition. Some minor granular washout was observed at select locations of the roof. (See Photo 23).
- 3) Along the common walkways/corridors, TRC observed confirmed instances of concrete spalling and delaminating finish (See Photo 15-17).
- 4) Steel reinforcement of the exterior stairwells was observed to have areas presenting with minor corrosion (See Photo 18)

- 5) TRC recommends that all identified instances of concrete spalling be professionally restored.
- 6) TRC recommends that columns with vertical surface corrosion have the stucco removed to assess the extent of underlying corrosion to the steel reinforcement, and/or cathodic protection lines prior to restoration.

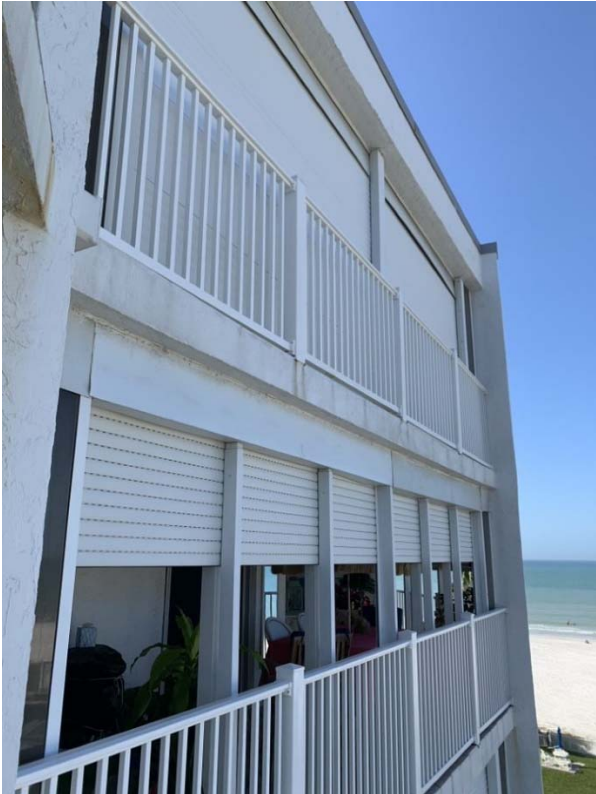
Photo 3

- Balcony damages:
  - Throughout the observed balconies, general damages observed included vertical surface corrosion on columns, improper grouting and waterproofing of balcony tiling, minor concrete cracking, and minor concrete spalling (See Photo 3-14).

- 4) During TRCs visit, some balconies were observed with evidence of potential water intrusion underneath the applied tile and in some instances along the slab edge. TRC recommends a full building balcony forensic investigation of the waterproofing applications and the integrity of the concrete. This investigation should map all concrete spalls, hollow stucco, as well as instances of hollow and delaminating tile. Further, the balcony railings (including their fasteners and anchors) should also be inspected at that time.

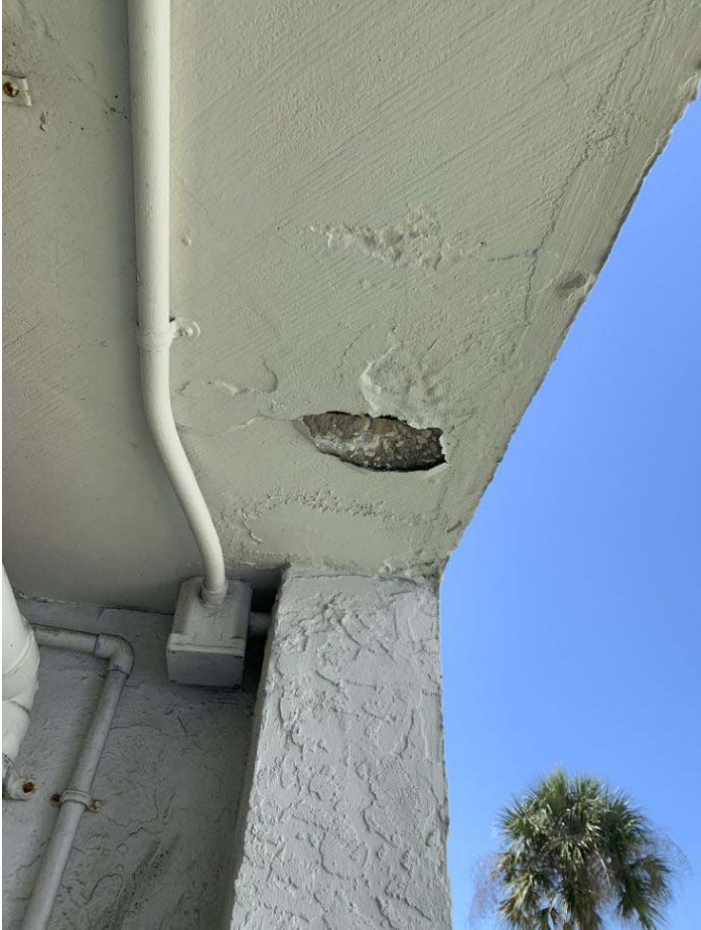
Photo 19

- Parking Garage:
  - Within the parking garage TRC observed instances of concrete spalling on the ceiling, as well as vertical surface corrosion on columns (See Photo 19-21).

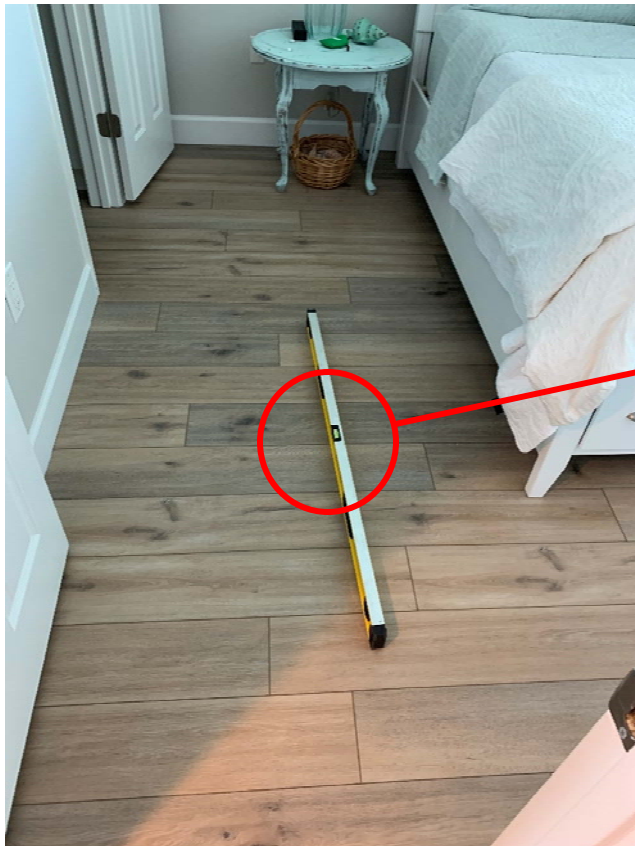
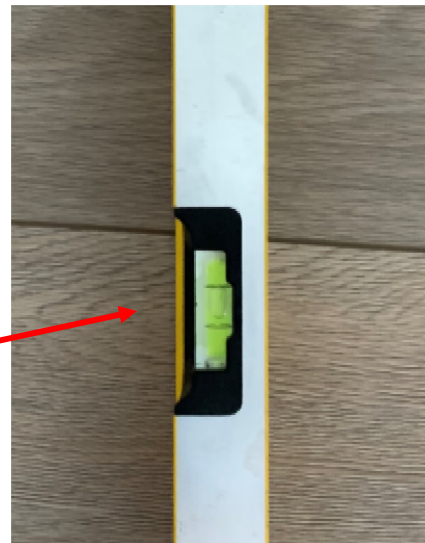
Photo 24

- Within Unit 603, The Owner reported concerns regarding the pitched interior floors of the unit. The interior floors are covered with hardwood flooring, making the review of the original concrete substrate non-permitted. TRC measured the hardwood flooring slope utilizing a 4-foot water level. In general, the flooring pitch was observed to be acceptable. Certain locations reveal pitched locations were found inside the kitchen area, master bedroom, and near the SGD inside the living room. The pitch floor is likely due to application error of the flooring as no signs of cracks and/or distress were found on the walls and ceiling adjacent to the mentioned locations (See Photos 24 - 27).

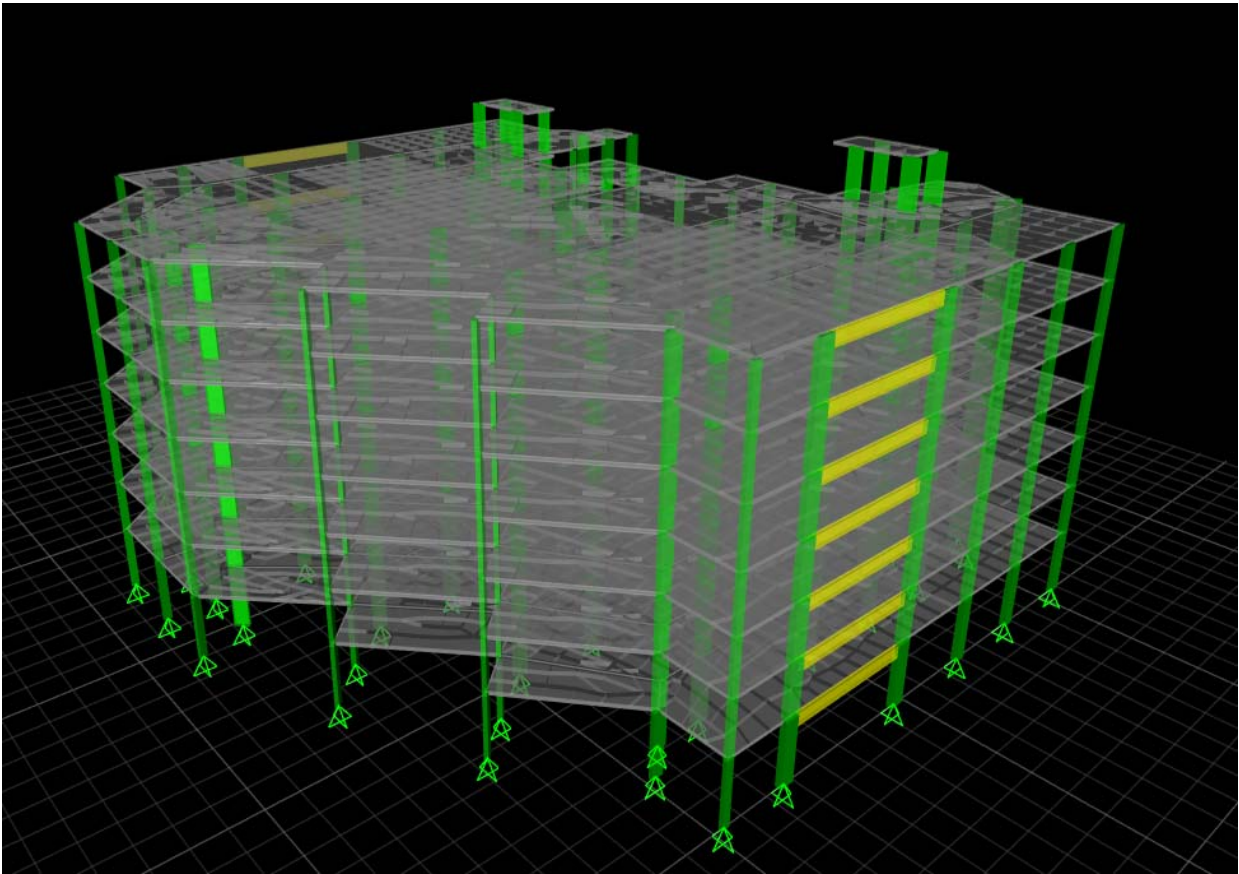
**Figure 1.** Etabs Model used for analysis.

In addition to the above noted analysis, TRC computed the loads in the columns and foundations and verified the capacity of columns using a finite element analysis software program, ETABS. See Appendix B Figure 1 for isometric view of the model. The columns were loaded under the same loads applied to the floor slab (SDL=20 psf, LL Balcony=60 psf, LL Rooms= 40 psf). Based upon our analysis of the columns and loads on the columns in accordance with the Latest Codes, it is our professional opinion that the existing columns have sufficient capacity to safely support the weight of the finishes described above. However, when verifying the capacity of the foundations, it was found that 20 psf of SDL exceeded capacity of one column foundation.

In order to check the capacity of the foundation was not exceeded, TRC reduced the SDL from 20 psf (which was the *heaviest* loading combination observed) to 15 psf and 10 psf to determine what SDL would allow for the piles at the foundation of the column to not be overstressed. At 15 psf the foundation is overstressed 10.8%, and at an SDL equal to 10psf the foundation is overstressed 7.6%. Typically for foundations it is acceptable to be up to 10% overstressing at foundations (See Appendix B Figure 4 for the building layout as per the structural drawings). The highlighted location on this figure shows the one foundation which experienced overstressing in TRC's analysis model. Based upon our analysis of the foundations and loads on the foundation in accordance with the Latest Codes, it is our professional opinion that the existing foundations, with the exception of the indicated foundation in Figure 4 of Appendix B, have sufficient capacity to safely support the weight of the finishes described above.

- 3) As our structural analysis revealed that the foundations at gridline J-6 are potentially overstressed, TRC recommends survey monitoring of column J-6 to measure any potential movement/settlement at this location over time. TRC will be able to assist in this process.

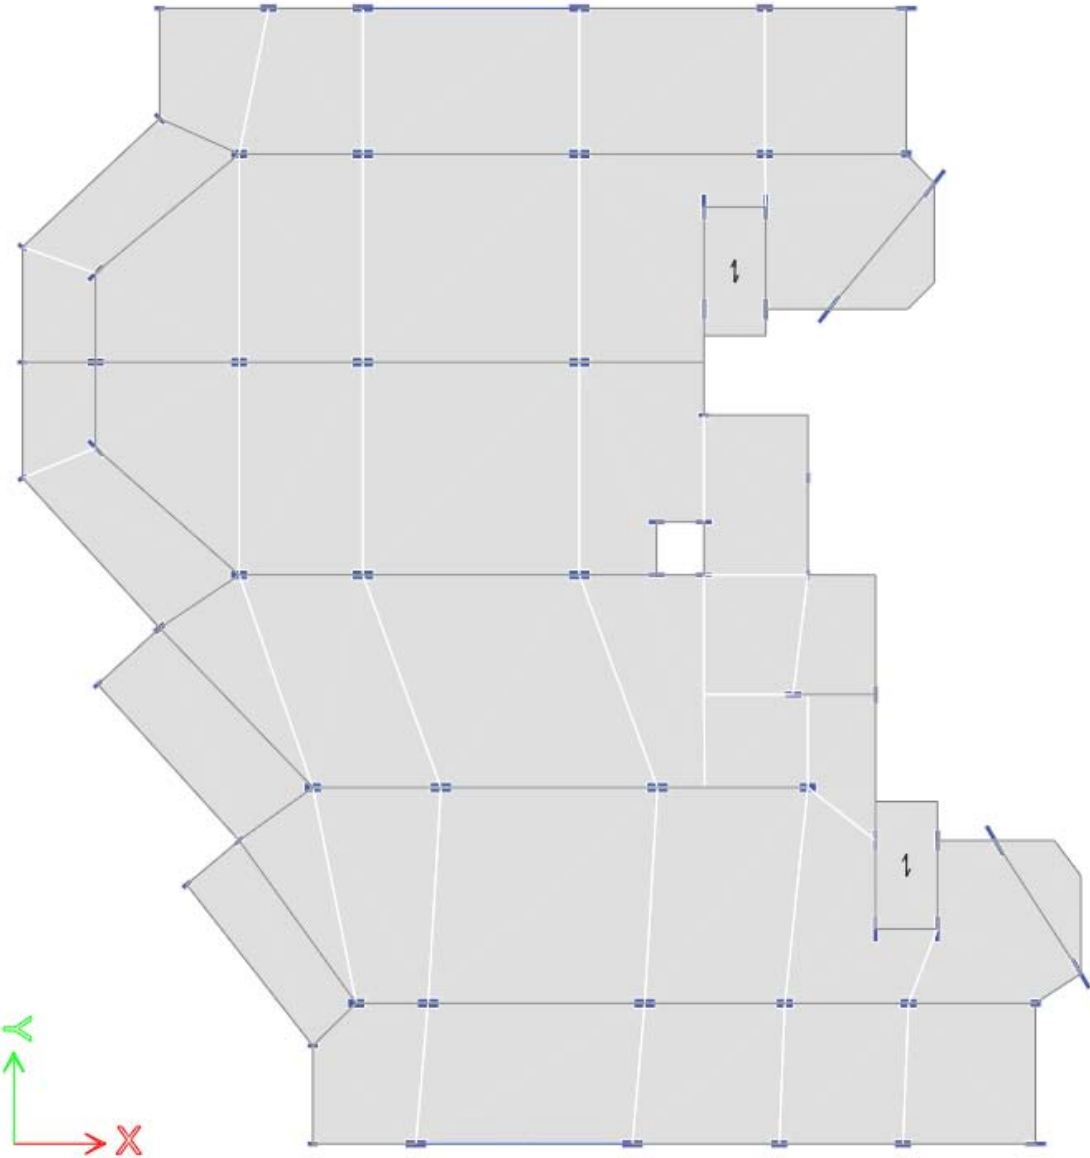
**Figure 2.** SAFE typical floor plate model.

Figure 2 in Appendix B shows the modeled floor slab that was used to confirm that additional slab reinforcement was not needed. It is important to keep in mind that the red labeled reinforcement on the floor slab in Appendix B Figure 3 is assumed reinforcement. The structural drawing set provided is not legible in certain areas of the slab, thus TRC had to make assumptions as to what reinforcement is likely in place at this bottom slab reinforcement. Based upon our analysis of the floor slab in accordance with the Latest Codes, it is our professional opinion that the existing concrete slab has sufficient capacity to safely support the weight of the finishes described above. However, in the areas where assumptions were made it would be recommended to find more complete existing drawings and confirm TRC's assumptions.

- 2) Given that TRC had to make assumptions due to illegible portions of the structural drawings, TRC recommends finding the original structural set, or a set that is more legible, to confirm the slab reinforcement analysis.

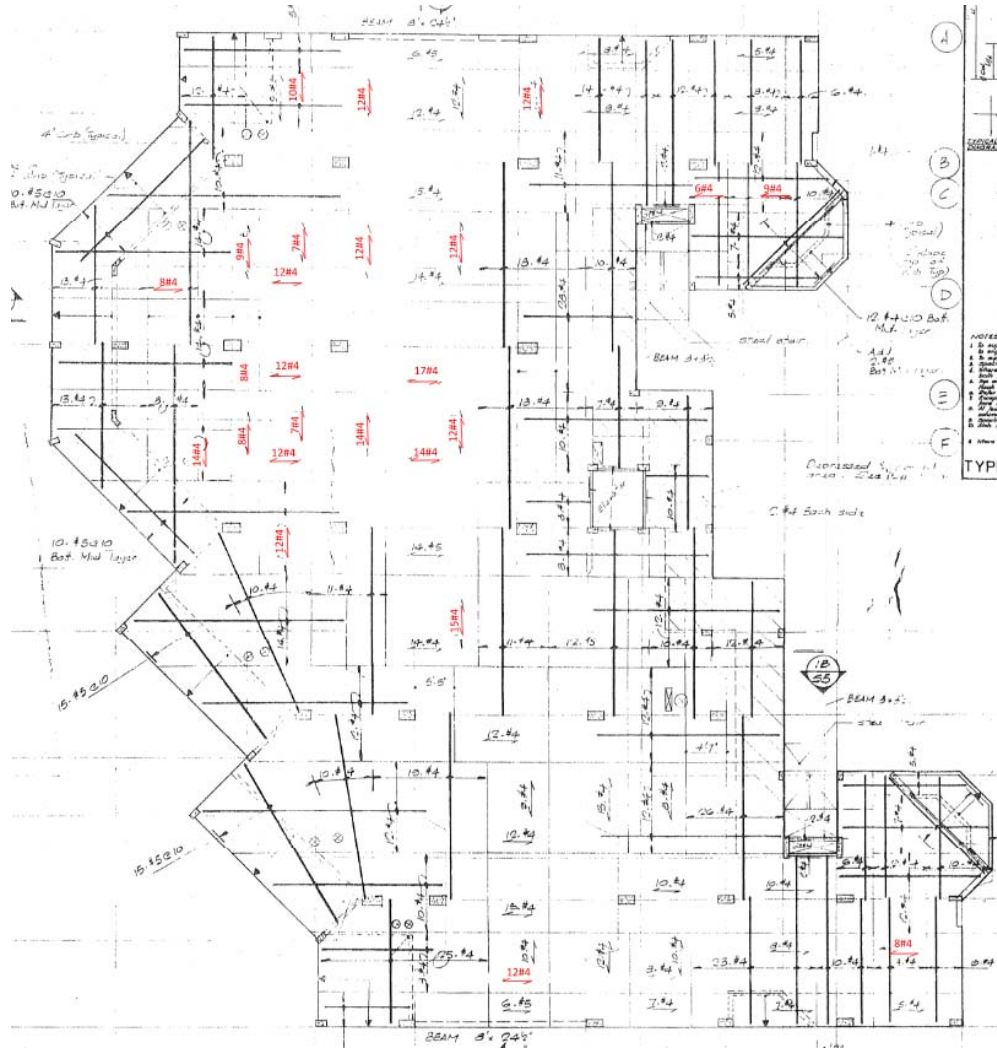
**Figure 3.** Assumed reinforcement at areas of structural drawings that are illegible from provided scanned set (See assumptions made in red).

- i. Note that a portion of the structural drawings was not legible and assumptions had to be made for slab reinforcement where marked in red in Figure 3 of Appendix B.
